Torrance Schools: An Urgent Wake-up Call

*A Report of the Torrance Unified School District
Facilities & Asset Review Committee
June 2007*

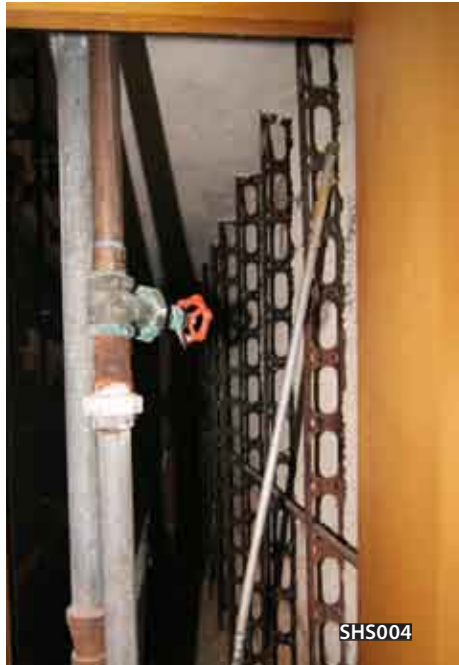
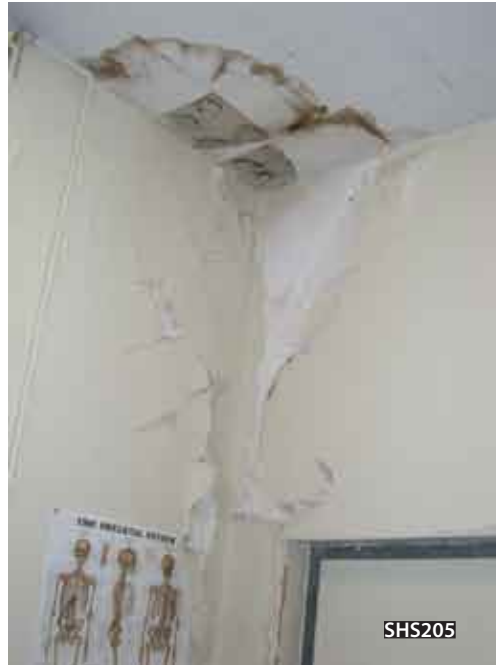
After half a century, galvanized water pipes in the walls are badly corroded. Different galvanized water pipes burst recently at South High, flooding rooms in two buildings. Torrance High has a locker room where none of the showers work. West High has rooms where the heat won't turn off, as well as many rooms without heat. North High has a science room with no electrical power to the long wall and counter where instruments and microscope lights should plug in.

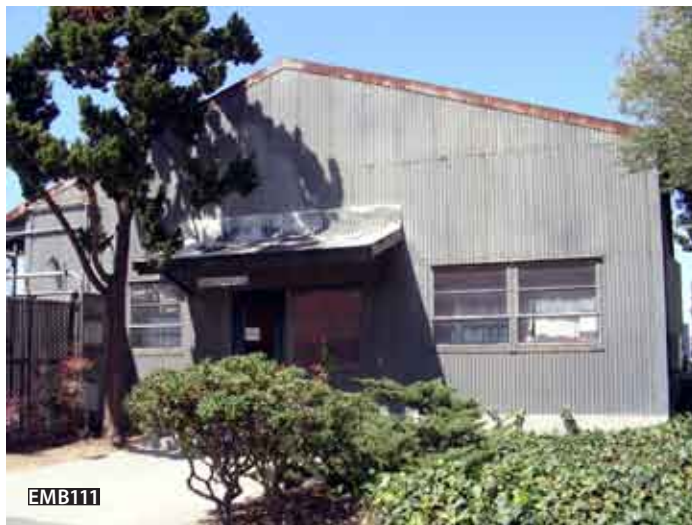
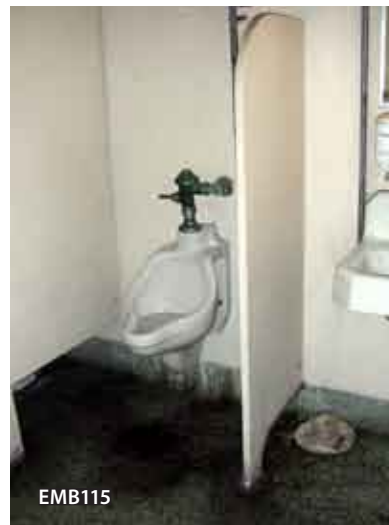
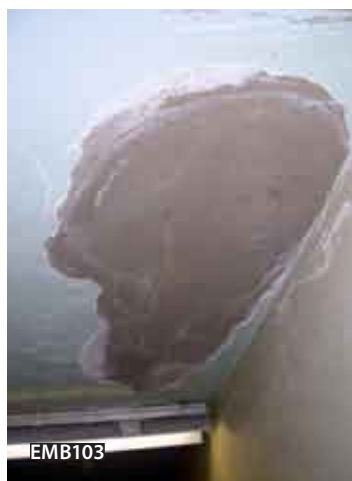
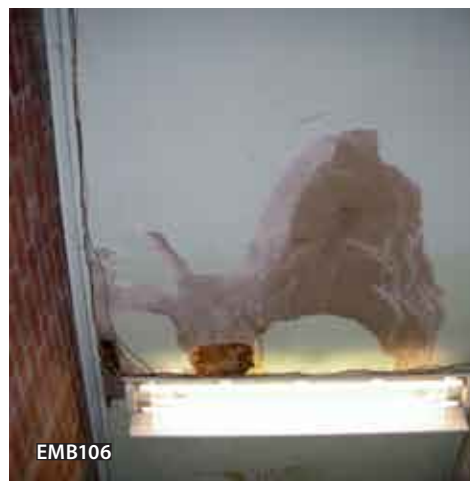
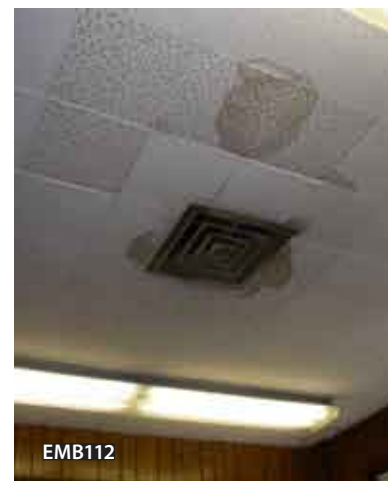
Heating for the building is inadequate. When staff is forced to use space heaters to keep warm, electrical service is often interrupted due to electrical overloads. The roof leaks in areas. The building is not ADA accessible or at all friendly to those who might need accommodation.

Other departments, Purchasing, Maintenance, and the Educational Materials Building (EMB) are across the street from the District Office. This divides many departments. Purchasing resides in a in a metal building (EMB111). Plumbing and fixtures in many cases is original showing the signs of decades of wear (EMB115). Roof leaks in many of the buildings are evidenced by stained and damage ceiling tiles (EMB103, EMB106, EMB112).

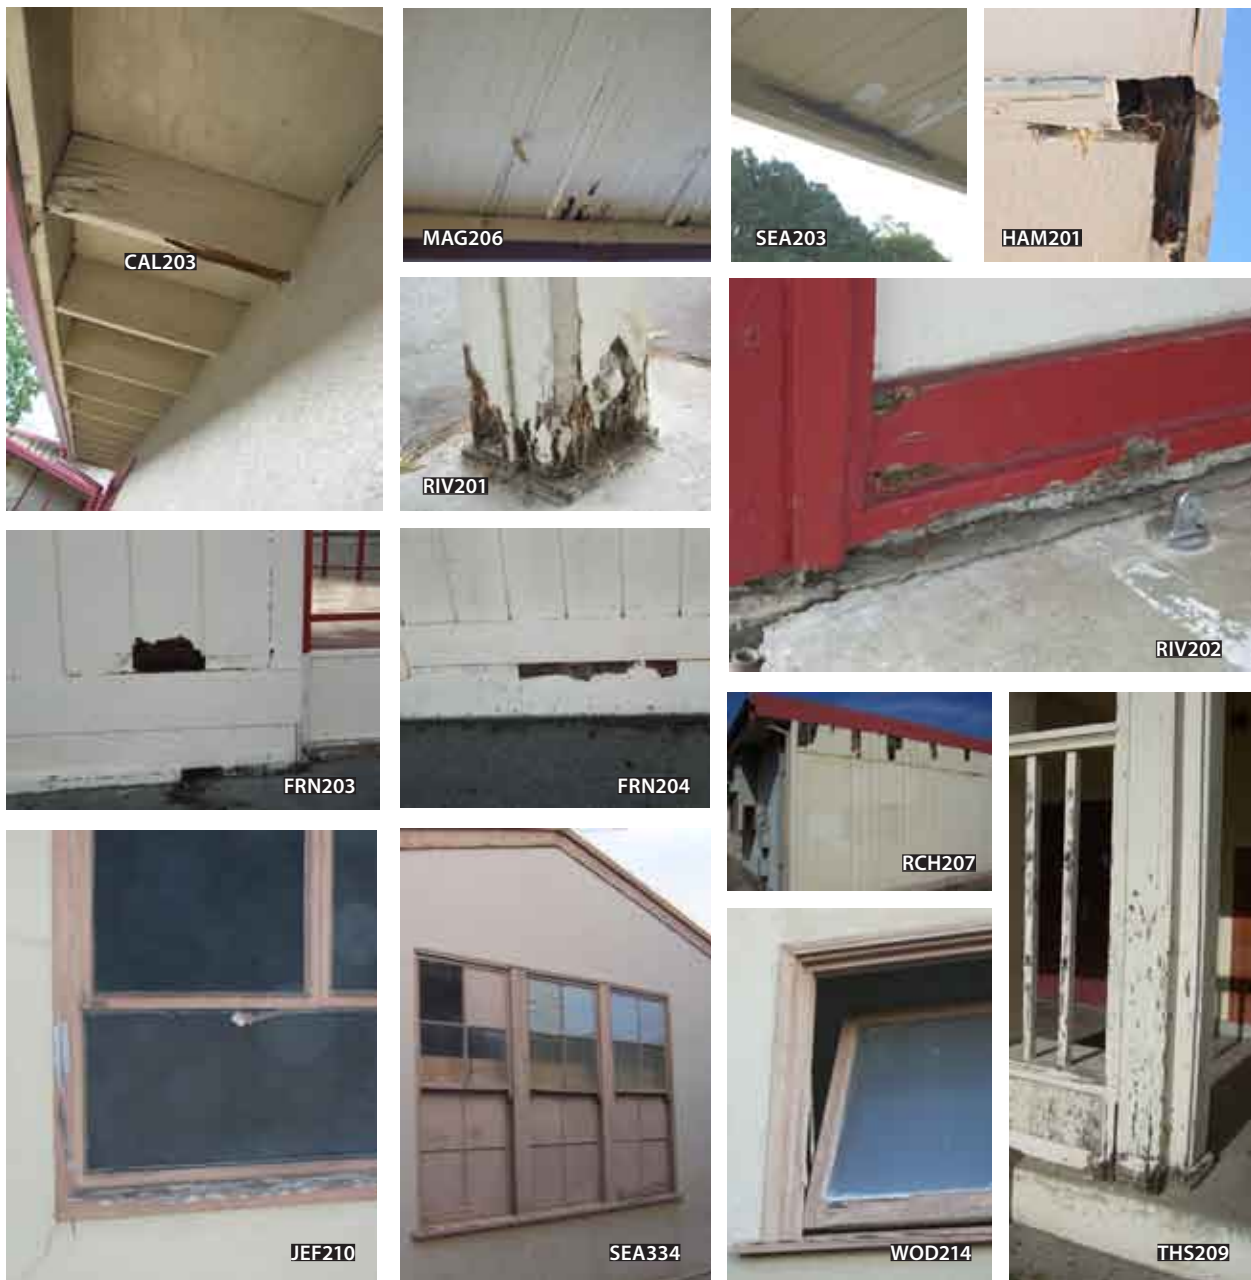
Exterior wood is susceptible to termite damage, rot, and weathering. Termite damage in an eaves joist is shown in CAL203. Wood rot and termite damage in wood arcades is shown in MAG206 and SEA203. Also, there are examples of wood rot just behind the fascia boards on arcades (see HAM201). Termite damage is shown in a support post in RIV201, and in cafeteria siding, low to the ground in RIV202.

Termite damage in the siding of a portable building is shown in FRN203 and FRN204. Sometimes portable building wood siding peels off just from weather exposure, as shown in RCH207.

Some of the older buildings have wooden window frames and sills, where the paint has long since peeled off, and the wood has weathered (see JEF210, SEA334, and WOD214). Similarly, there are weathered wooden railings and pillars (see THS209).

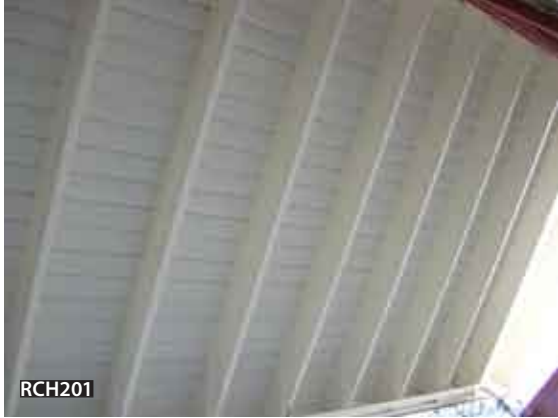
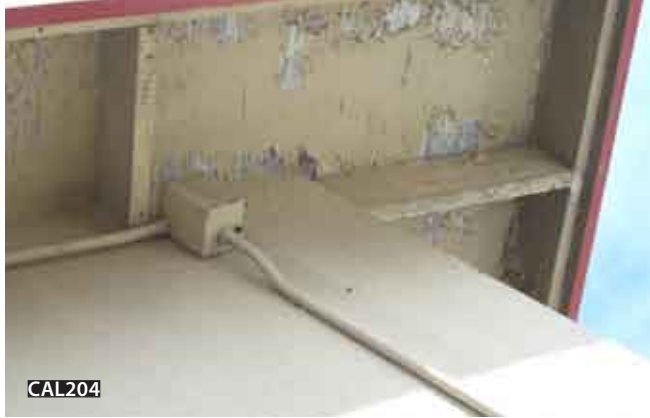
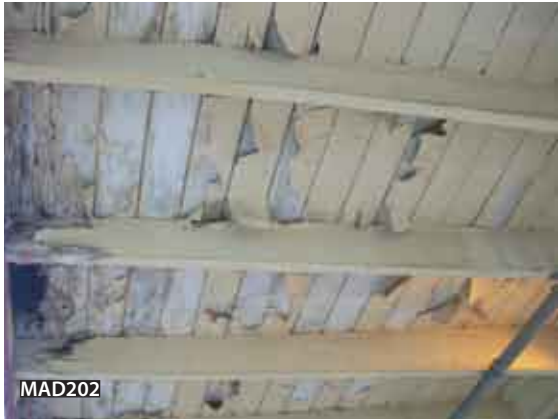
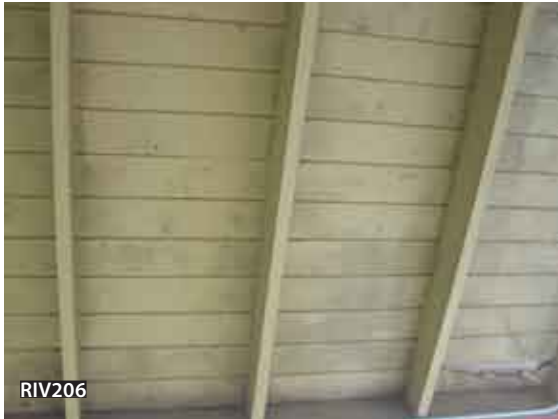
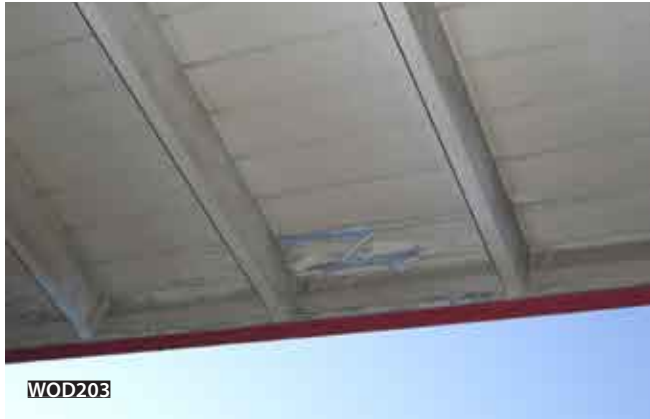
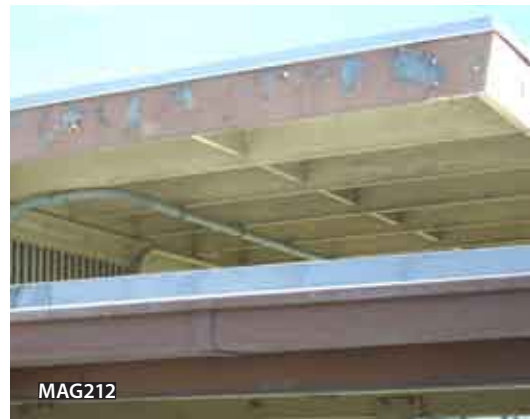
Some eaves paint up well, and then look fine (RCH201). However, peeling paint and mildew is common on elementary school and middle school eaves, district wide (see CAL204, MAD202, MAG210, MAG211, RIV206, WOD203, and WOD208). When eaves areas get wet, termites are attracted.

Fascia board at the edge of the roof is exposed to sun and rain. With time, fascia board paint peels, and the wood weathers (see MAG212). Flashing is sheet metal angle bridging between the roofing material and the top of the fascia board. Damaged flashing is shown in ANZ111, which exposes the fascia and roof boards to rot.

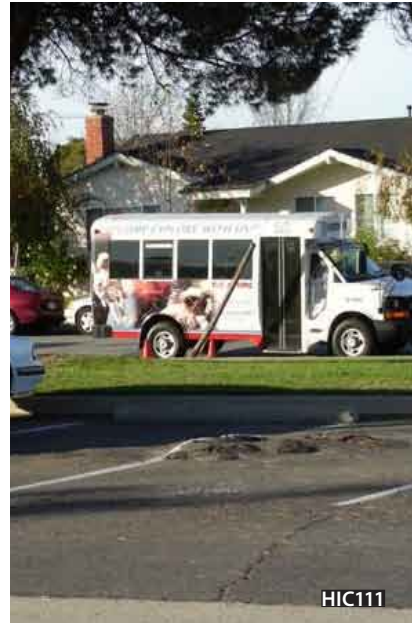
Asphalt raised by tree roots is the most dramatic (HIC111 and RIV108). Highly uneven asphalt, raised by tree roots, is found in walkways, playgrounds, and parking lots. Cracked, eroded, and raised asphalt presents trip hazards.
