Torrance Schools: An Urgent Wake-up Call

*A Report of the Torrance Unified School District
Facilities & Asset Review Committee
June 2007*

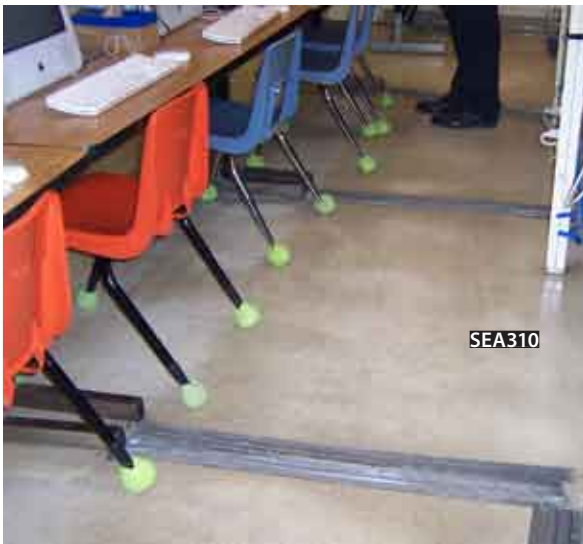
The electrical needs of science and computer labs are not being met at some sites. In some cases, there are not enough outlets to service the amount of equipment. Other sites do not have enough electrical capacity, and, therefore, throw breakers when too much equipment is used. Computer labs at Seaside and Walteria have many extension cords duct taped to the floor in order to get power to computers (WAL112, SEA310). This type of fix raises safety concerns, and begs for a better solution.

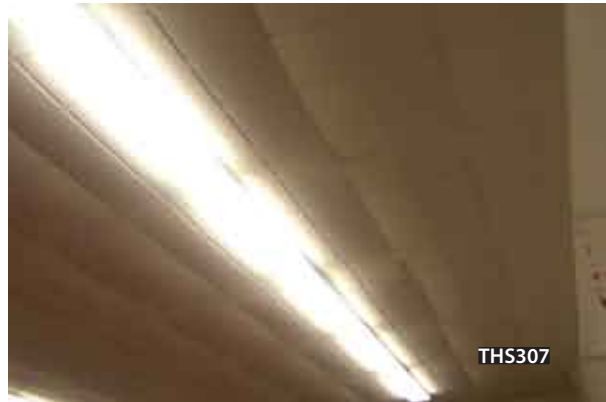
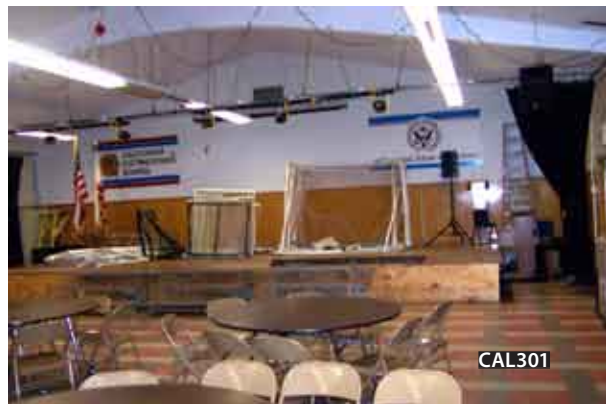
Lighting in many rooms has been upgraded, but some of the rooms still have older, less efficient lighting systems (THS307, CAL301). These should be upgraded both for better illumination and to save electricity costs.

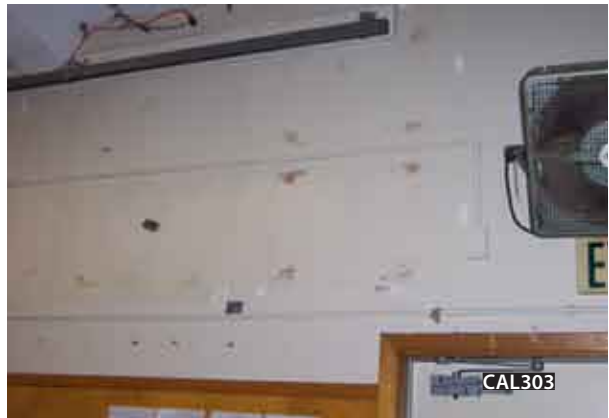
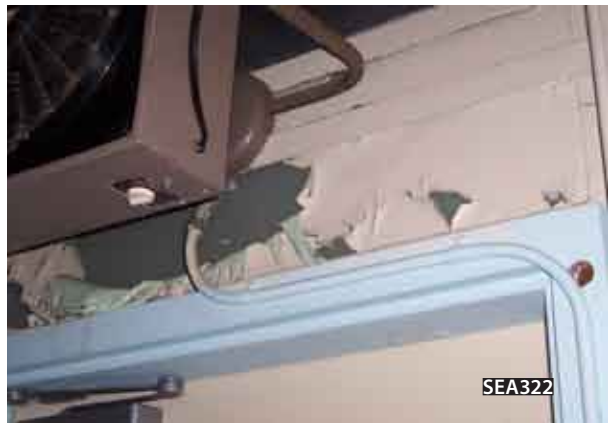
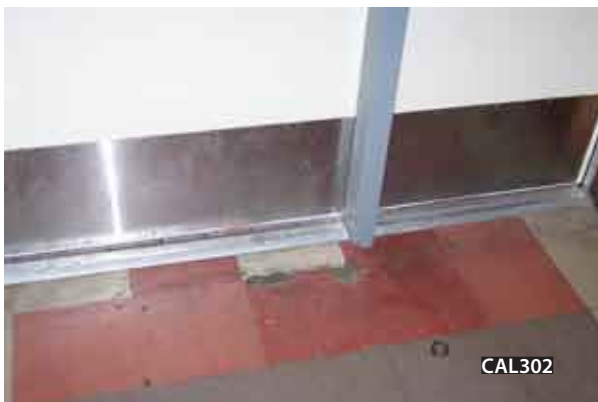
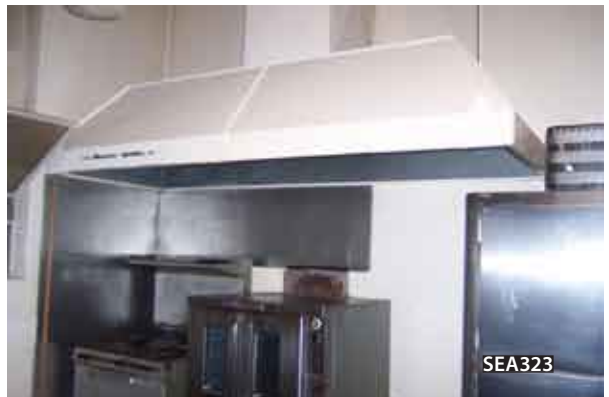
The cafeterias around the district have not benefited from modernization. Cafeterias are basically the same as the day they were built. Parent groups have built stages (MAG425). Lighting for some stages appears makeshift (CAL301 and MAG327). There is no standardization to the stage lighting. Floors, ceilings and lights are also original in many cases. Holes in asbestos flooring are patched by filling with cement (CAL302). All cafeterias are in need of painting and refurbishing (CAL303, SEA322, SEA323).

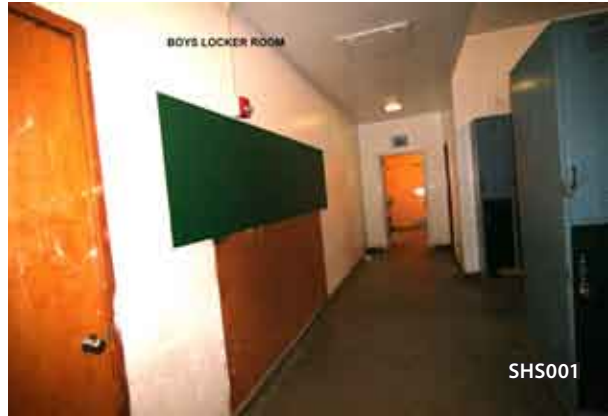
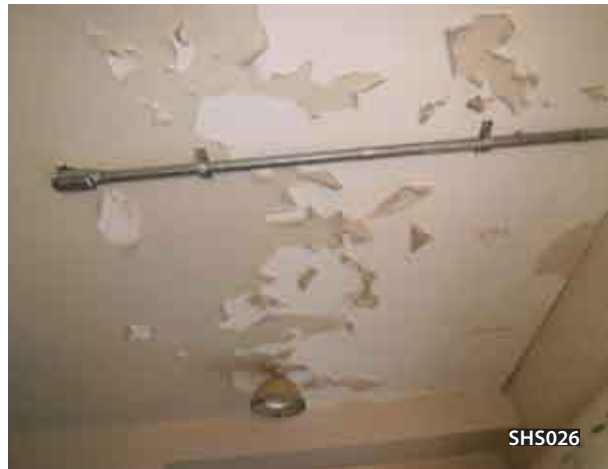
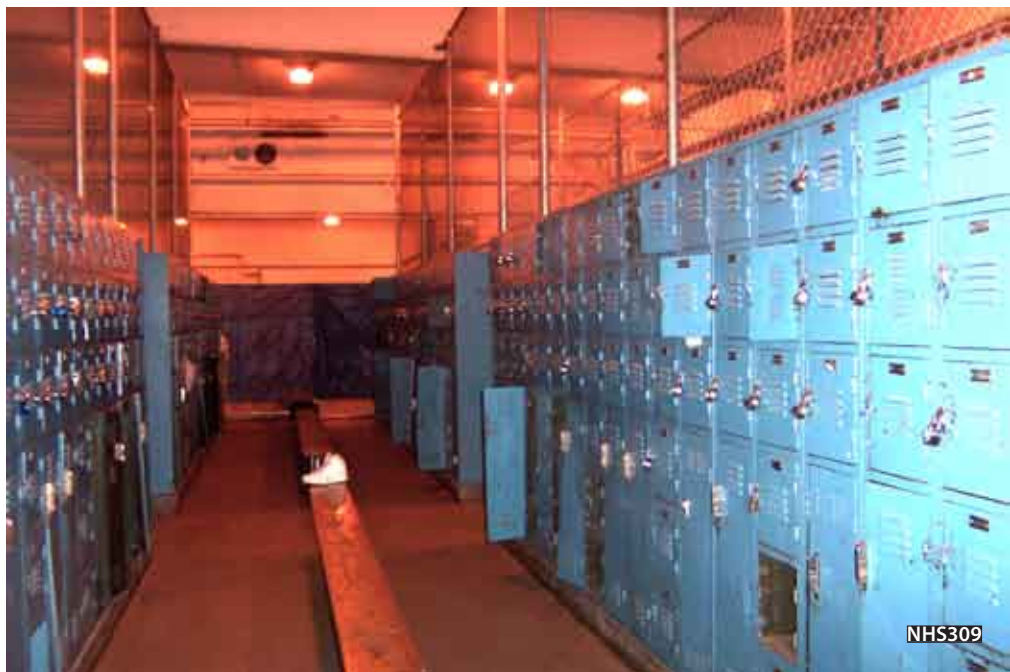
High school gymnasiums for boys and girls consist of locker rooms, showers and restrooms, and interior basketball courts and stands. All of the high schools gyms are in need of some repair. Some locker rooms have benefited from community support and dollars. Others have not fared as well (SHS001, SHS026). Plumbing issues plague all high school gyms. Showers, tile, and plumbing are original in most cases – old and worn. Water heaters do not function to allow students adequate showers. Both drainage and water supply are unreliable in many cases. Locker rooms are antiquated and many lockers are not useable (NHS309). The restrooms in the gyms also show the wear and tear of decades of use. Stalls and fixtures are both rusted and inadequate to meet today’s needs.

The Torrance High basketball court floor has dead spots where the ball doesn’t bounce back as much. Some gym floors have a few loose boards. Most gym floors could use refinishing. The North High dance floor has termites and wood rot. Torrance High has bent metal bleachers that can’t all be extended from the wall.

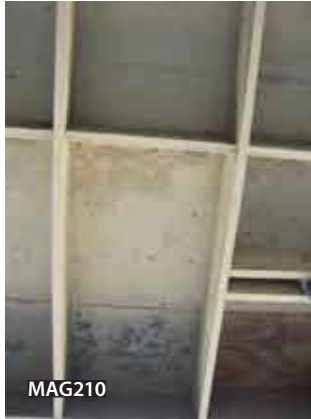
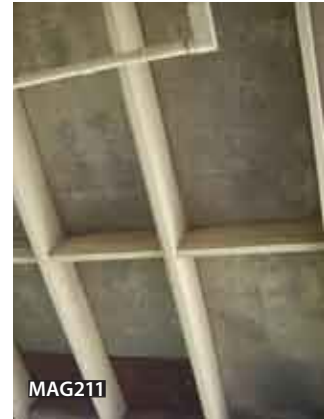
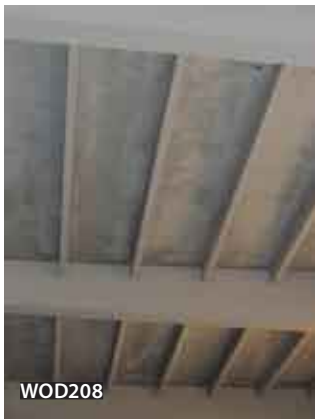
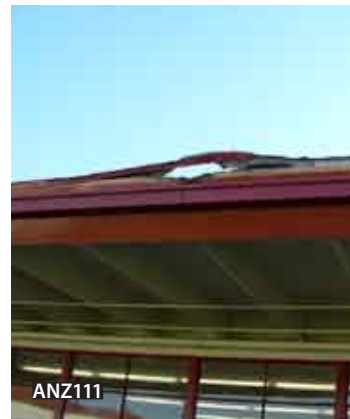
Some eaves paint up well, and then look fine (RCH201). However, peeling paint and mildew is common on elementary school and middle school eaves, district wide (see CAL204, MAD202, MAG210, MAG211, RIV206, WOD203, and WOD208). When eaves areas get wet, termites are attracted.

Fascia board at the edge of the roof is exposed to sun and rain. With time, fascia board paint peels, and the wood weathers (see MAG212). Flashing is sheet metal angle bridging between the roofing material and the top of the fascia board. Damaged flashing is shown in ANZ111, which exposes the fascia and roof boards to rot.

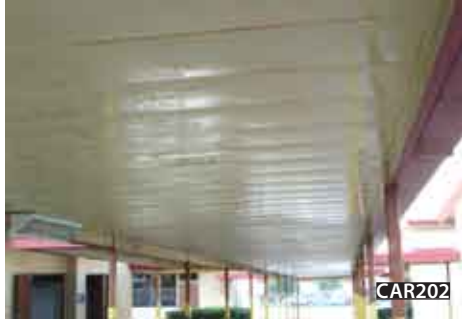
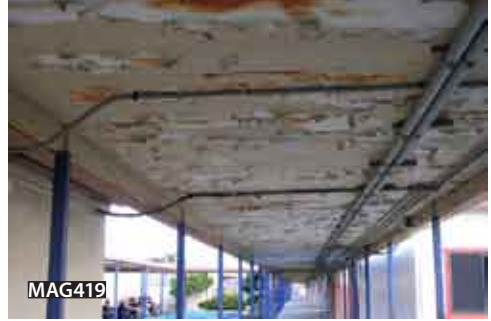
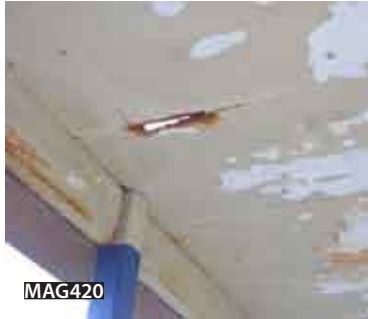
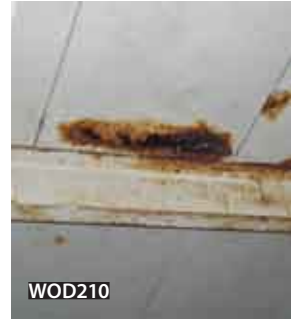
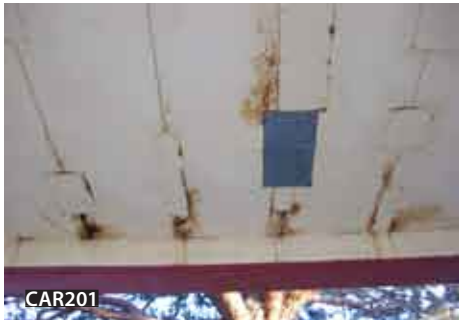
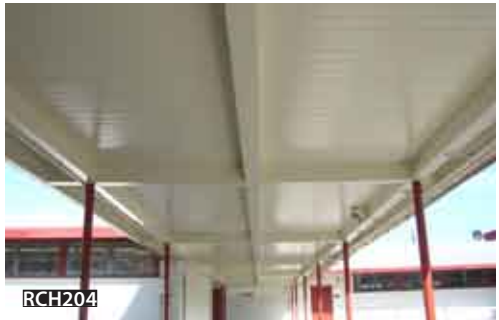
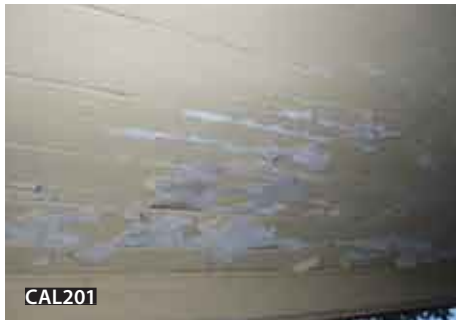
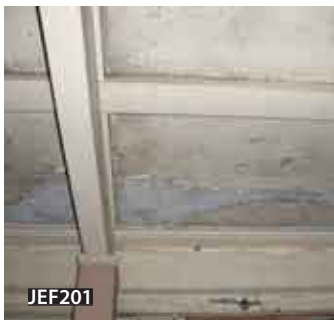
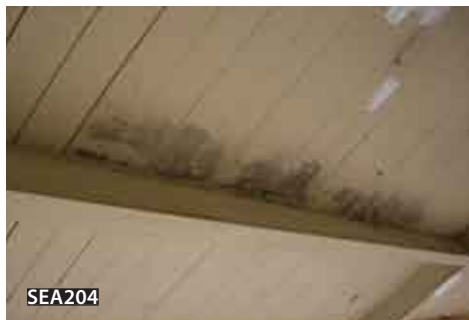
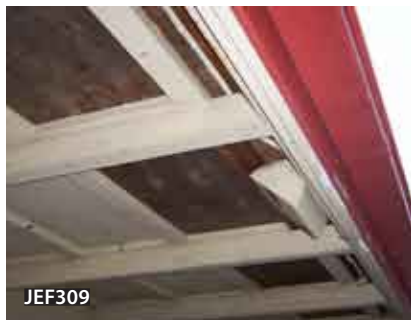
Metal arcades are generally galvanized steel, painted on the bottom side. The top surface tends to wear through and rust before the bottom. With exposure to the night sky, condensation forms on the entire bottom surface (see CAR202), as well as the top. With time, the paint peels, and rust forms on both sides, resulting in a very dilapidated look (see MAG419). Further rusting along the seams results in holes rusted all the way through, for example, see MAG203, MAG420, VIC207, and WOD210.

Some wood arcades are made with painted tongue-in-groove boards, with roofing to seal the top, some with narrower slats, and some with plywood. Wood arcades can look good with recent paint (see RCH204). However, even with recent paint, if the arcade pools water and leaks, the paint peels (see ARL202). In this example, the arcade slopes to a low point, and there is a lip on each side of the arcade, with no gutter or downspout.

With time, the paint on wood arcades peels and looks dilapidated (see, CAL201 and MAG204). Peeling paint on wood arcades may not always indicate water leakage. However, water leakage certainly results in bad cases of peeling paint (see WAL102). The peeled paint exposes weathered wood, which in many cases seems solid. However, there are examples with wood rot and termites too. There is significant mildew on some wood arcades, for example, JEF201 and SEA204 (some here being covered with KILZ paint). Also, some arcades sections never got painted (see JEF309).

As a simple repair, sometimes, metal patches are riveted over the holes (see CAR201). A renovated

metal arcade is shown in TWR202, where the old support pillars were retained, but the sheet metal top was replaced.

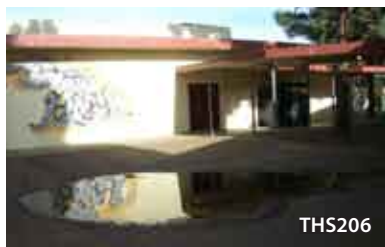
Standing water at two high schools is shown in THS206 and SHS055, at low points where the old drain is no longer functional. A non-functional drainage system at Carr Elementary leaves the kindergarten yard flooded whenever it rains (CAR209). Also, asphalt areas on many campuses do not have adequate runoff, causing periodic pooling of water, and regular occurrence of standing water.

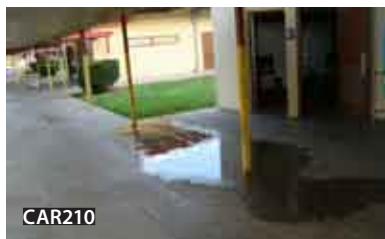
CAR210

At many campuses, irrigation water forms streams and puddles on the walkways (CAR210, CAR211, MAD206, and VIC205). The wet walkways are slippery. The problem is a combination of ground slope, low points with no drain, and irrigation system configuration. At several schools there are drainage culverts/ditches that don't have a continuous, downward slope, or else, no drain at the low end (WOD308). Also, some rain gutters/downspouts don't leave the water in a place from which it can drain.

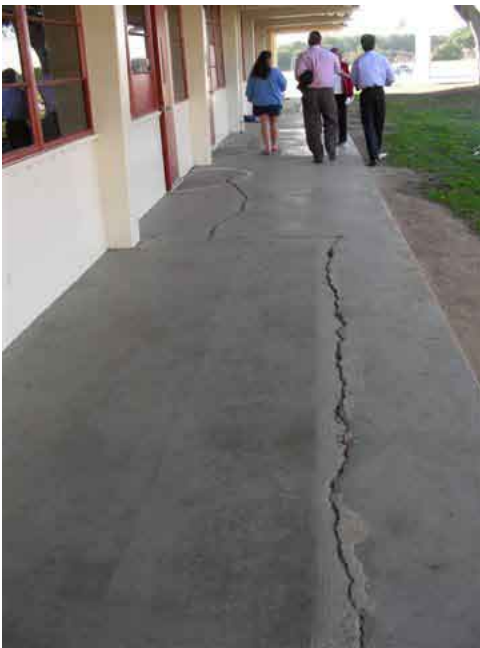
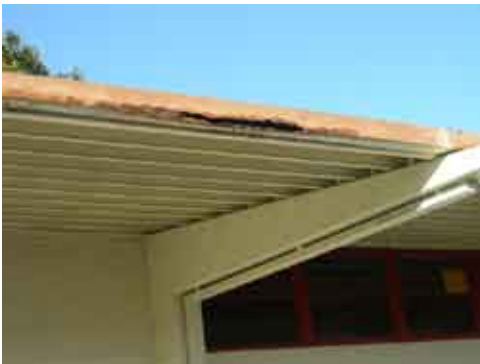
Yukon Elementary School

- Yukon was one of the first schools to benefit from Measure R – most of work done, all restroom renovated
- Rain gutters rusted through
- Needs new windows
- Original 1950's wooden stage needs to be replaced
- Some plumbing problems, one classroom leaks when it rains
- Drainage – “Lake Yukon” forms on field during rains
- Not enough lighting in hallways
- Backs up to Freeway I-405 – concerned about truck traffic accident on I-405 ending up on playing field – need to look into building a concrete wall between freeway and school site for safety

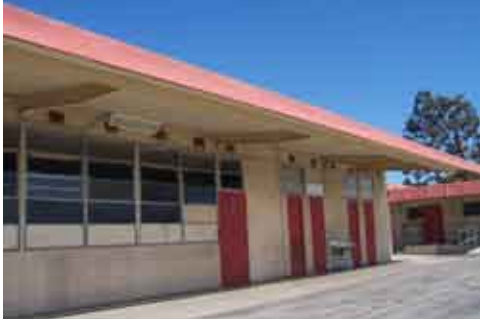
J. H. Hull Middle School

- Effective September 2007, 28 out of 32 classrooms including administrative offices and cafeteria can not be occupied by students
- For the 2007-08 school year, the 700 students and staff will be transferred to Levy Adult Center site and the current J.H. Hull campus will be used for adult education classes

Note: Hull was subject to State legislation mandating that its CalCor buildings, 28 of its 32 structures, be withdrawn by September 2007. State laws prohibit K-12 education to take place in these buildings, but allows for adult programs.

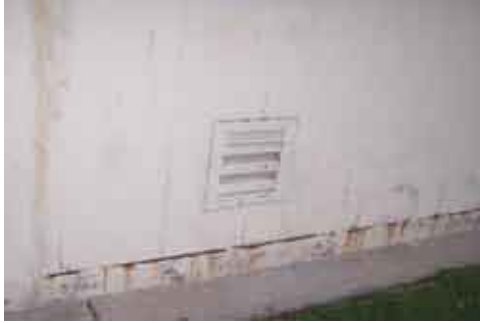
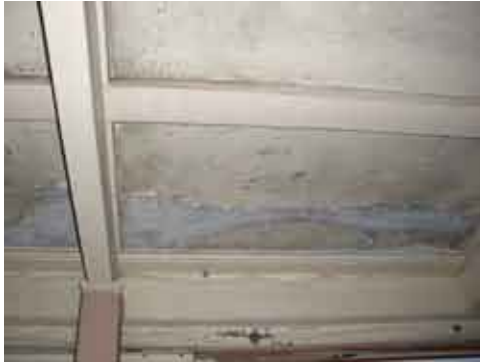
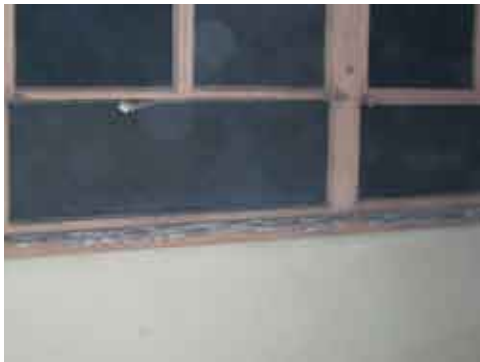
Jefferson Middle School

- Windows need to be replaced
- Upgrade of restrooms not completed and automatic features do not work
- Drainage problem - Water built-up at north side of Cafeteria

- Pendent lights without stabilizing wires for earthquake
- Loose and water damaged ceiling tiles in classrooms
- Cafeteria is too small for 670 students

- Support gussets on the southwest of wings C and B have big cracks and missing chunks of concrete
- Damaged lockers are unsightly
- Bell does not ring in every room

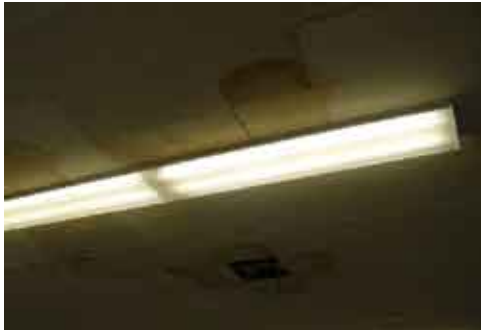
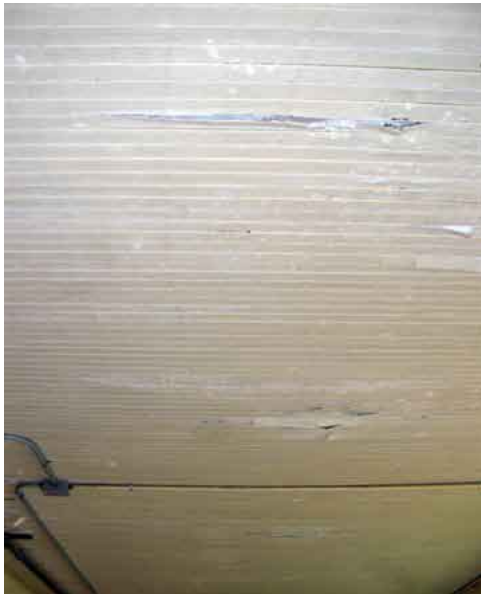
Bert Lynn Middle School

- Modernization limited due to dispute with contractor - all contracted work was stopped
- 1 set of restrooms modernized (modernization of restrooms has reduced the number of stalls to make the restrooms ADA compliant)
- Original 1950s arcade, peeling paint, dry rot
- Roof needs replacement; rain leaks in band room and cafeteria
- Fields have standing rain water and poor drainage
- All windows and doors need to be replaced
- No window coverings in any classrooms
- No adequate lighting in hallways for evening events
- Original floor

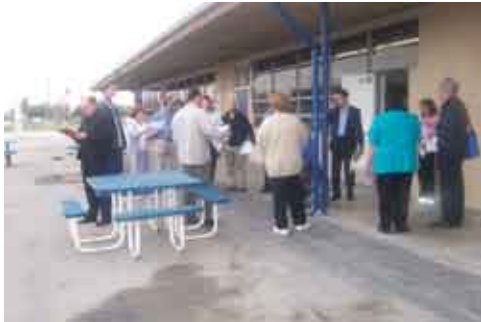
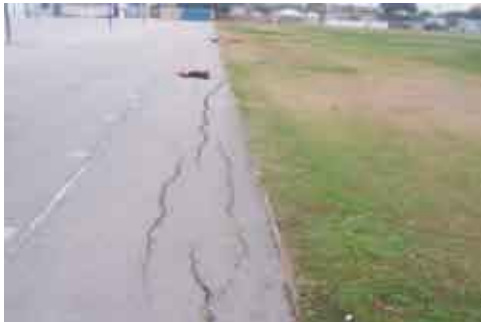
Magruder Middle School

- Needs new paint – peeling paint on fascia trim board and eaves, mildew in plywood eaves
- Cracked stucco on corners of buildings
- Damaged rain gutters
- Uneven asphalt pavement
- Peeling paint, rusty metal on arcades
- Need new chain link fence
- Plumbing-leaky valve was observed at Room 27
- Foundation problem at Room 27
- Drainage problem – flooding, standing water
- Poor irrigation system
- Cafeteria is too small for 800+ students
- Stage in cafeteria should be upgraded (tripping hazard due to aging plywood)
- 1 set of restrooms have not been renovated
- Parking lot has many cracks in asphalt – small parking lot does not provide enough parking for teachers and staff
- Library to be relocated, currently in one of the CALCOR portables that must be replaced by state law

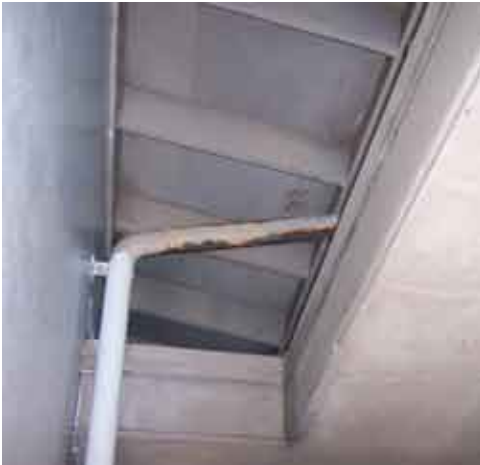
North High School

- Windows need to be upgraded/replaced
- Exterior lighting not working
- Gym exterior shows wear and tear
- Heaters don't work in the administration building

- Aging gym floors need to be refinished or replaced
- Lighting in both gyms needs to be replaced
- Football field and track are in poor condition
- Bleachers are unsafe - south side football seating has broken boards, rotten ends and deep cracks and splinters in the seat boards

- Drainage problems allow water to drain into the music building and Saxon Hall
- Not enough science labs
- Raised and uneven pavement in many walkways create a hazard

- Some rain gutters rusted completely through (eg. North side of building P)
- Dance room floor has wood rot and termites;
- Poor irrigation of the fields – dead spots and flood spots, clumpy grass clusters

- Dirt track should be upgraded to all-weather track
- No data connections in some buildings
- Gym restrooms have old, rusty fixtures and no doors on the stalls

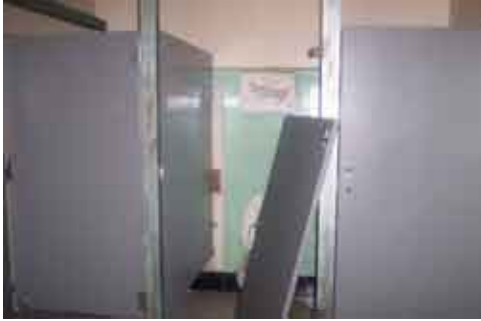
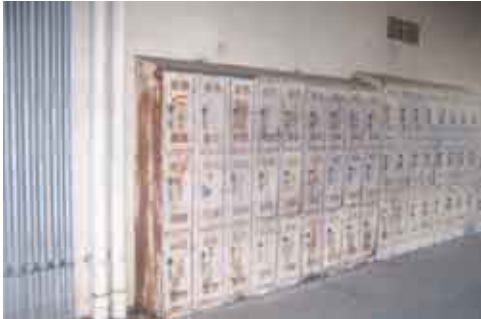
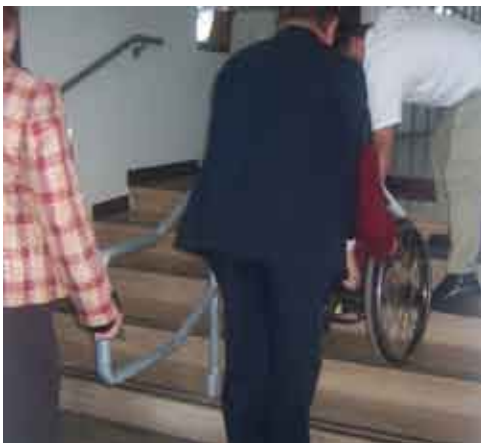
- Old roofs leak in classrooms leading to damaged ceilings, peeling paint, and deteriorating walls
- Gutters leak in arcades, drains are clogged
- Pavilion structure is deteriorating

- Windows needs to be replaced.
- Electrical systems in computer labs are not adequate for the amount of computers and equipment
- Old heating boiler issues in Buildings Q & R need to be replaced

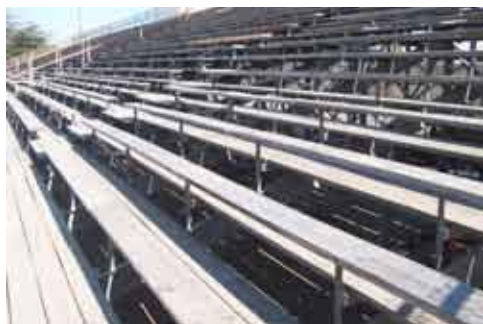
Torrance High School

- Bungalows have peeling paint, bare wood on fascia boards and bent or missing awning louvers
- Some wood columns are decaying
- Many buildings have peeling paint on eaves and fascia

- Some buildings need electrical and plumbing upgrades
- Several drinking fountains do not work
- Cafeteria has a roof leak, ceiling tiles are water stained, walls have stress cracks, kitchen flooring and ceiling tiles contain asbestos

- Gymnasium restrooms are in poor condition and showers lack hot water
- Clogged drains causing pooling water which attracts mosquitos
- Aging roofs need to be replaced

- Bldg G Café is old and undersized with ceiling and wall damage and a kitchen that does not comply with modern building standards
- Building F needs boiler and elevator

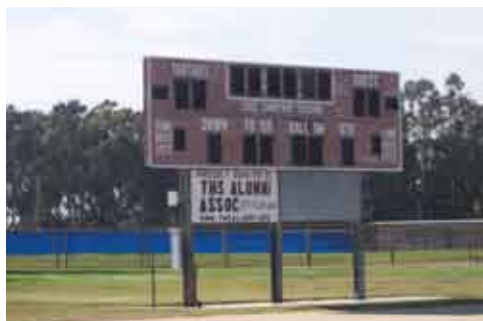
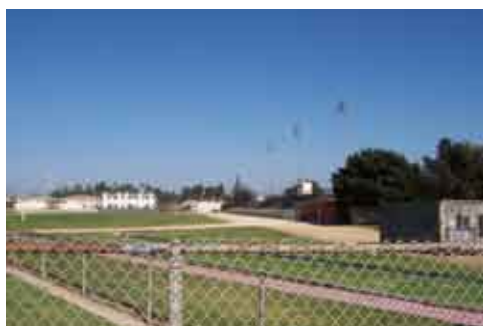
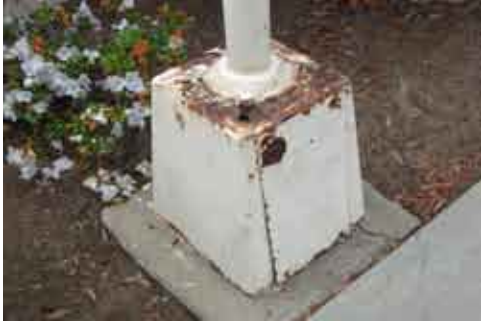
Torrance High School/ Zamperini Stadium

- Need new bleachers to replace rotting wooden planks
- Need new restrooms
- Need better lighting
- Football field and track are in poor condition

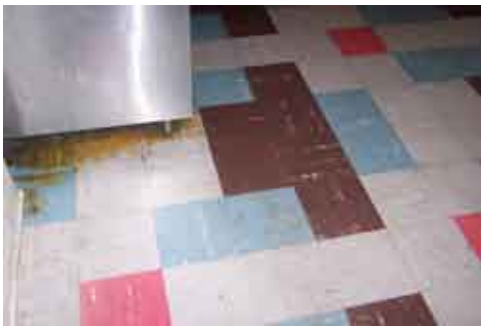
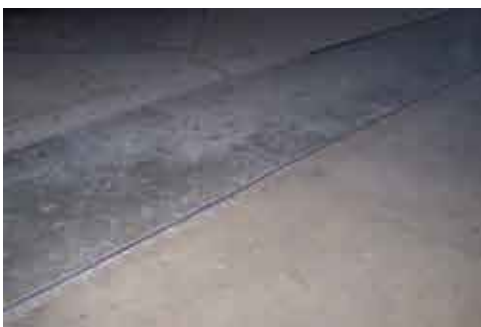
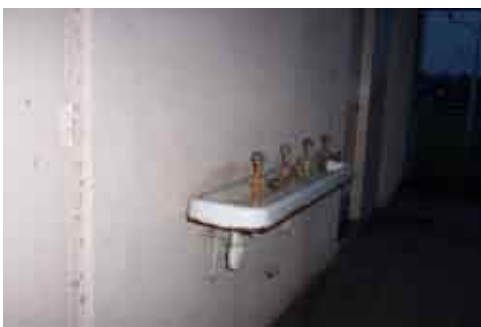
West High School

- Wood rot and termites
- Tree roots raising asphalt SW at Building 8 and SE of Building 9.
- Trees causing drainage and plumbing problems
- Boys locker room restroom sinks rusting and most don't work

- Locker room showers drip continuously
- Band shell drain blocked and floods with rain
- Inadequate electrical system in Drama Room
- Campus needs outdoor lighting for safety

- Central heating system showing signs of age
- Radiators don't turn off in some rooms
- Some rooms/office with no heat
- Boilers should be removed and replaced with something more efficient to heat rooms

- Added elevators don't work and leak
- Building 3 elevator does not go past 2nd floor
- Black top-safety issue, Concrete slab-uneven
- Concrete arcades don't drain, and water puddles on top

- Drinking fountain NW of gym, at stadium, rusted out
- Windows are original, some hardware not working and not accessible – blinds are old
- Entrance gates are in poor conditions

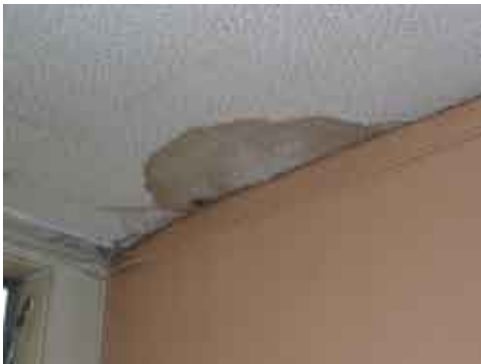
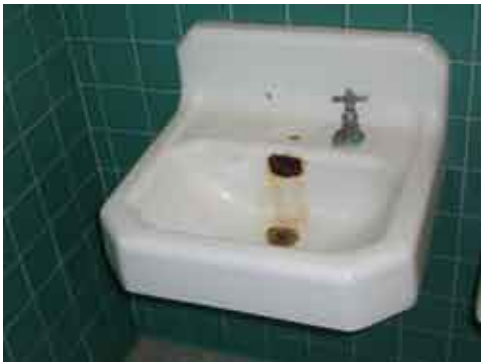
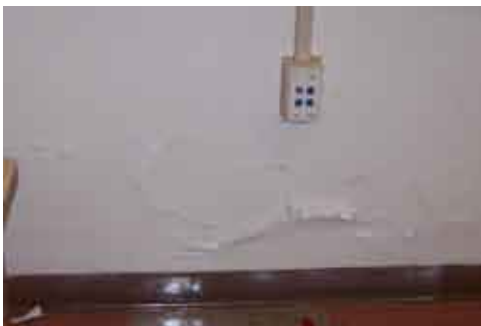
Hamilton Adult School

- Old galvanized plumbing occasionally leaks, restroom drains back up and very old and rusting fixtures in the restrooms need to be replaced
- Water damaged wall in building E
- Old doors on classrooms and restrooms with peeling veneer and holes
- Rotting wood on arcades
- Parking lot has cracks in pavement
- Electrical system is old and inadequate
- Drainage problems
- Roof leak in Building E and D, ceiling tiles need to be replaced

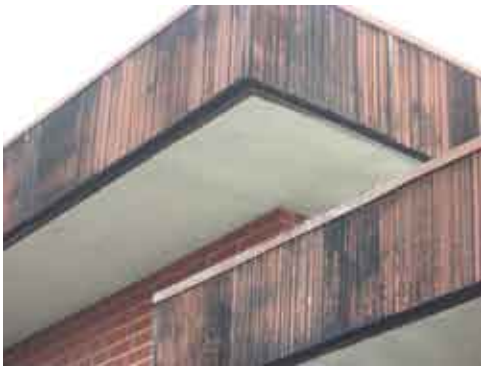
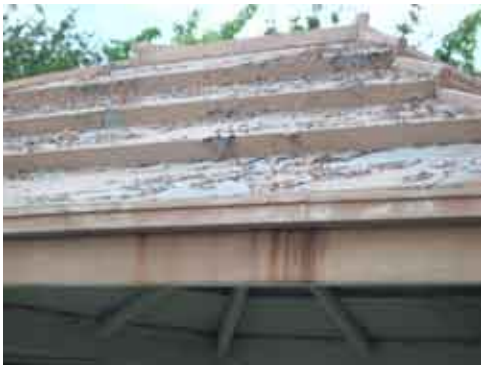
Levy Adult School

- All buildings need paint and fascia repair
- Canopy metal needs paint, signs of peeling paint in hallways
- Rusted gutters
- Windows boarded up in some classrooms
- Doors are in poor condition
- Dry spots on the field – irrigation issues
- Mildew around wood trim panel
- To be used temporary to relocate Hull Middle school

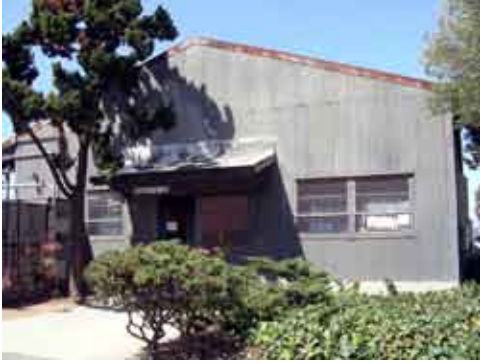
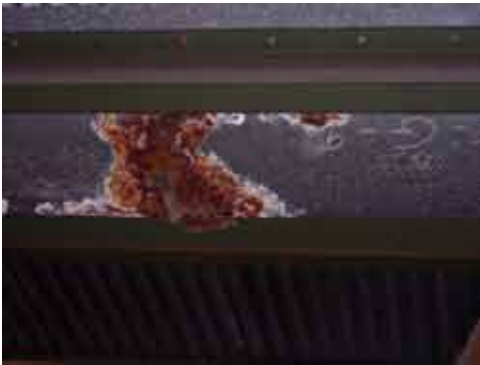
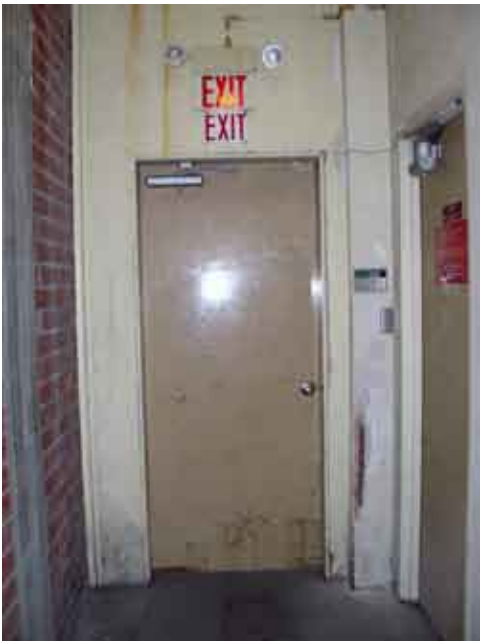
- Original building built in 1950's
- Not ADA compliant
- Undersized for size of district staff
- District staff is inefficiently spread out in District Office, EMB, Levy, and other facilities
- Shortage of meeting rooms
- Heating and cooling system is divided in four "zones." Making it difficult to maintain a uniform temperature and adding space heaters trip the electrical circuit breakers
- Electric capacity is not adequate to support technology
- Roof leaks
- Lighting dim in hallways
- Parking lot needs repaving; someone recently tripped on cracks
- Personnel Commission staff in small trailer
- Needs new carpet
- Basement used for file storage
